## The PRO Services Solution

# ITT Goulds Pumps increases efficiency in one of the world's largest oil and gas operations, based in Russia

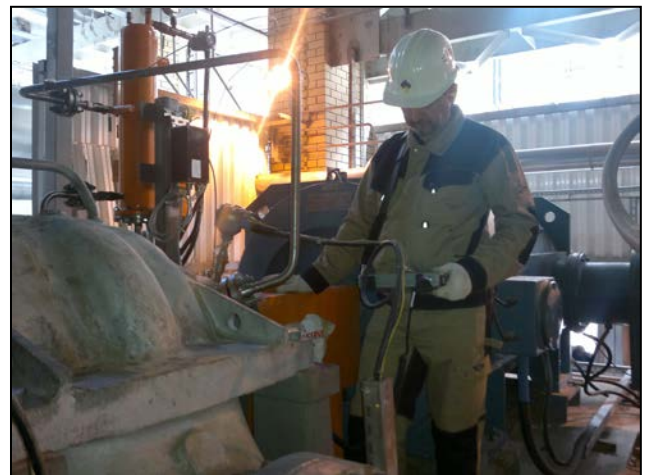
ITT Russia's diagnostics specialist takes vibration readings from the problem pump after its impeller trimming.

Once the customer had decided on required duty points, the ITT team calculated the new trim, created trimming sketches and supervised the customer's disassembly, impeller trimming, rotor balancing, pump assembling, position installation and test run. Impellers have been trimmed in three pumps—one from each unit of technological equipment.

During the pumps' test run with crude oil, ITT performed thorough vibration diagnostics for all pumps and motors. They found possible issues with the bearings in one of the motors.

The main problem with the motors' overload was completely eliminated and the vibration problem was significantly reduced. The ITT team determined that they had made the correct trimming to the impellers. They recommended keeping the modified trim until the pump was tested under real process conditions. Trimming the impellers to smaller diameters (as the OEM's plant contact had advised) would not have been advisable—it would not have affected the vibration much, since the vane passing frequency would no longer be the main component of vibration in the pumps.

The system is operating at a heightened efficiency and the ITT PRO Services team has recommended that the condition of the motor bearings needs to be maintained and checked on a more frequent basis. For example, the detailed vibration monitoring of the motor's bearings should be done once a week, by evaluating the high frequency vibration envelope, assessing the peak factor and/or employing the shock pulse method.
