A Wireless Vibration Monitoring System

A 1,050 MW power plant adds a state of the art monitoring system.

By Gregg W. Rebenstorf, P.E. Southern California Edison

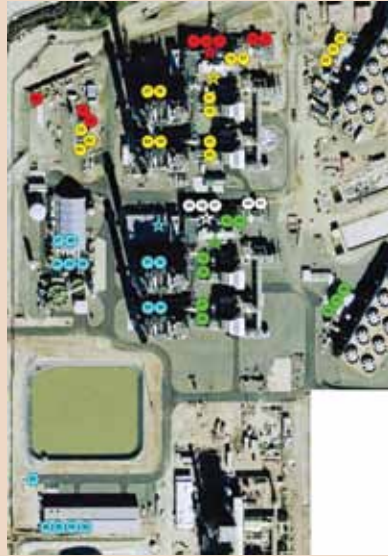
FIGURE 1 SENSOR OVERVIEW

Shown in Figure 1 are two power blocks in a slide along arrangement of 2-on-1 combined cycle units. The steam turbine deck for each block is shown to the north above the two CTG-HRSG trains. There are five CM-DM circuits shown in the plant general arrangement with each circuit represented by a different color. The colored dots represent the DMs; the CMs are represented by stars. To improve communication strength, temporary cell phone CMs were added on the north side of each steam turbine deck, which are shown in white and red stars. When the mesh network software is installed later in 2009 these two temporary CMs are expected to be eliminated. Locating the CMs at a high point in the plant allows some equipment DMs to communicate via line-of-sight.

The CM receives data from the DMs and provides a secure connection to the ProNet platform via LAN, DSL, cell or 802.11 wireless routers. Mountainview has two CMs on each of the steam turbine decks and one on the control building roof. The control building CM communicates to the ProNet platform through a DSL line, while the four CMs on the turbine deck have cell phone connections to the internet.

Since the signal emitted from an antenna is cone-shaped and 360 degrees around, the higher elevation prevents the bottom of the cone from being cut off if it hits the ground. This also allows for greater signal bounce from adjoining structures.
