ProCast Gets Power Plant Back On-Line

The 60" Foster Wheeler Circulating Water Pump at a midwestern power generating facility had been vibrating excessively. However, the plant had hoped it would continue to operate through the sum-

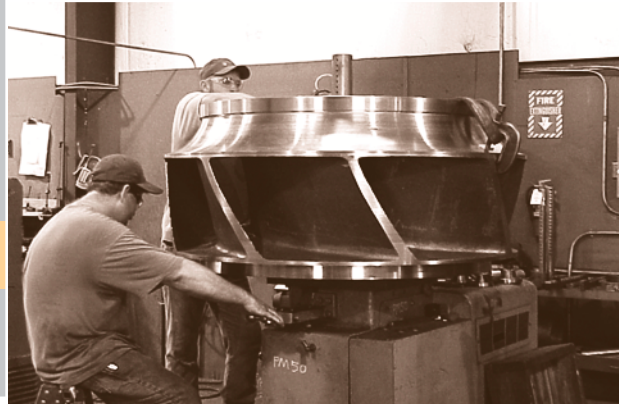
Impeller being keyed during the machining phase.

The impeller was then shipped to our production machine shop in Zachary, Louisiana where it was machined, balanced and shipped within the three week required time.

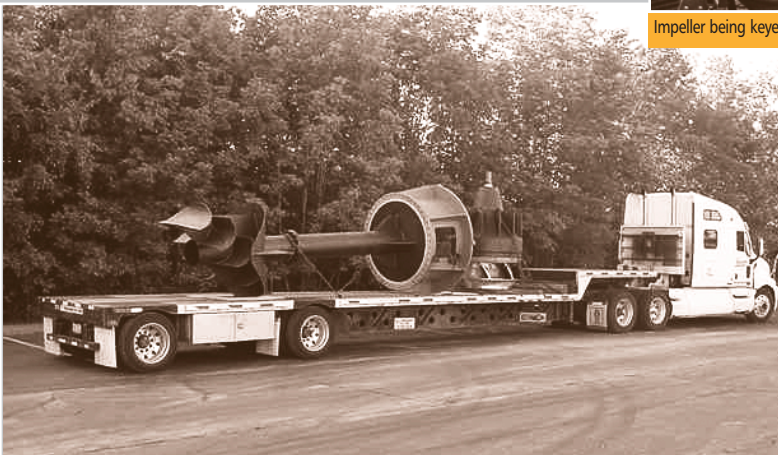
One of two tractor trailers required to deliver the repaired pump to the power plant.

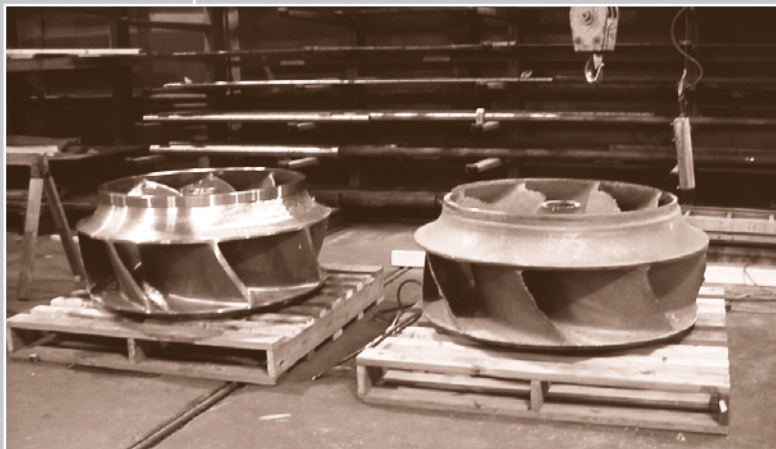
As you can see from the photograph, the old bronze impeller was severely worn. ProCast received the old impeller at their foundry/pattern operation in Cullman, Alabama on June 30. Working through the 4th of July weekend, the impeller was completely re-manufactured. The pattern was quickly completed, thanks to our skilled team. Immediately after the pattern completion, the impeller was poured in 316 SS.

(3) week turnaround on this 60" Foster Wheeler Circ Water Vertical. Right is the old bronze impeller. Left is the new 316SS impeller.

Cleveland Pump Repair advised the pump has been installed and successfully started up on August 1. The customer was very pleased with the quick turnaround and the pump's performance.
